LEVEL 3 BRIDGE INSPECTION AND LOAD RATING REPORT – MCCROWS ROAD BRIDGE

MCCROWS ROAD BRIDGE

ARARAT RURAL CITY COUNCIL

APPROVER: **GEETHIKA SANDARUWAN** *BSc.Eng (Hons), MIEAust, CPEng, NER, RPEV*

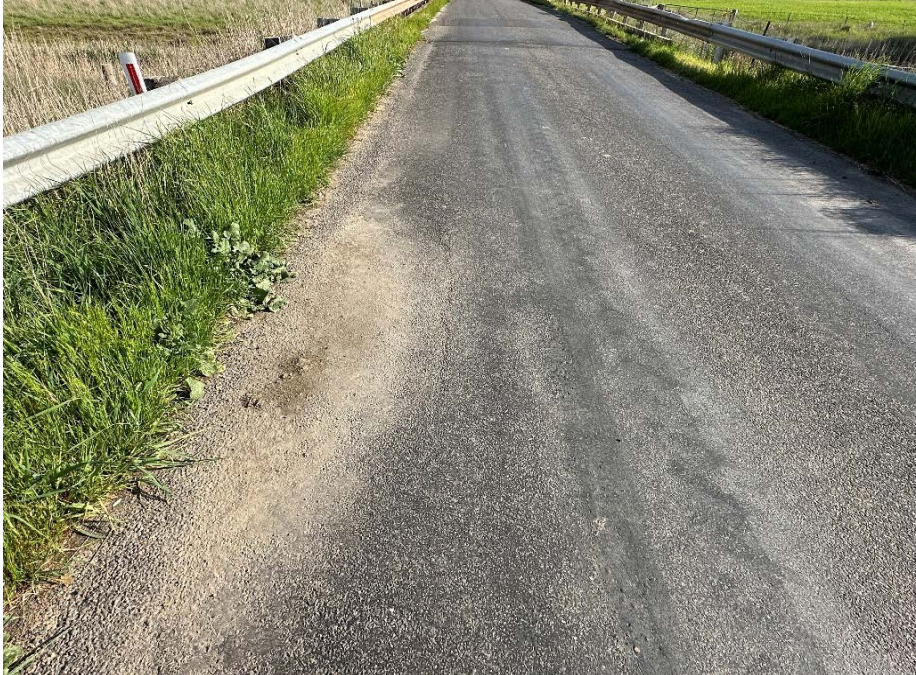
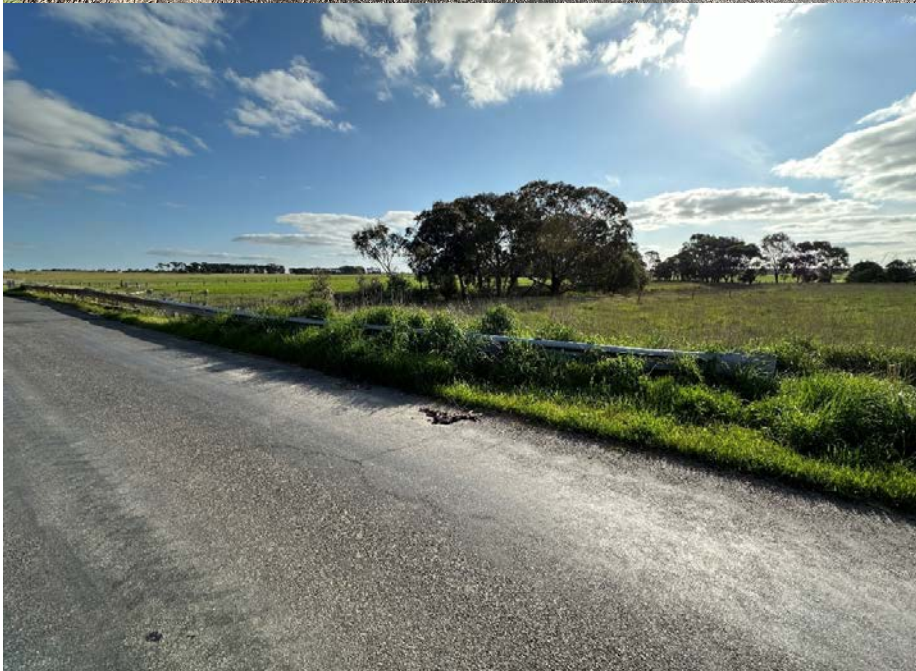
1. The northern approach exhibits minor depressions and cracking in the carriageway. Monitor at level 1 inspections.

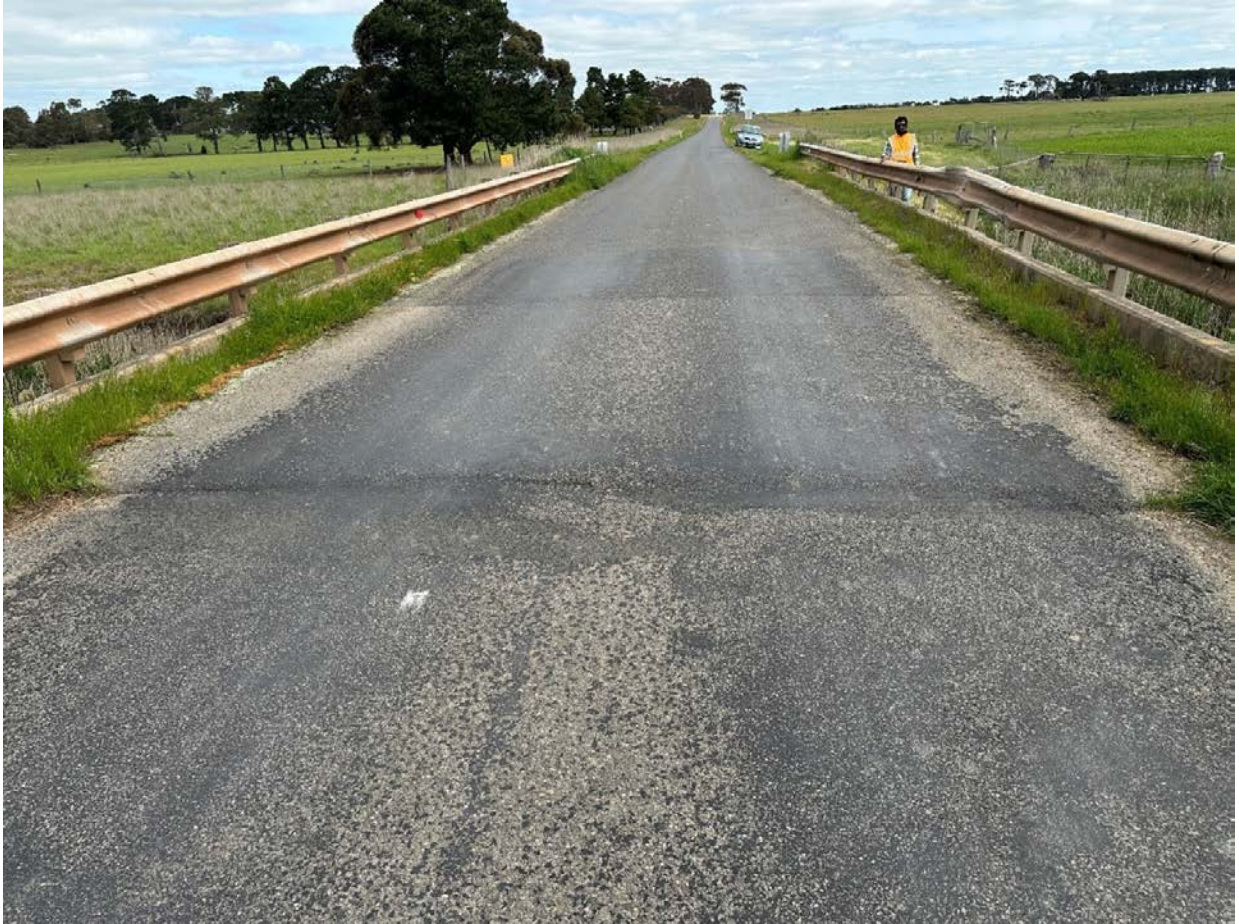
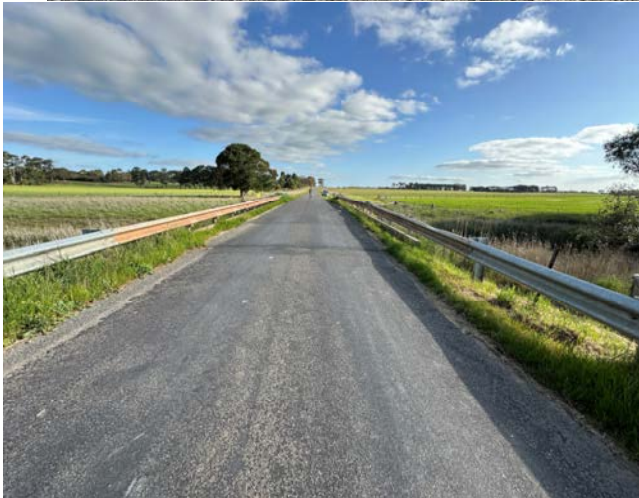
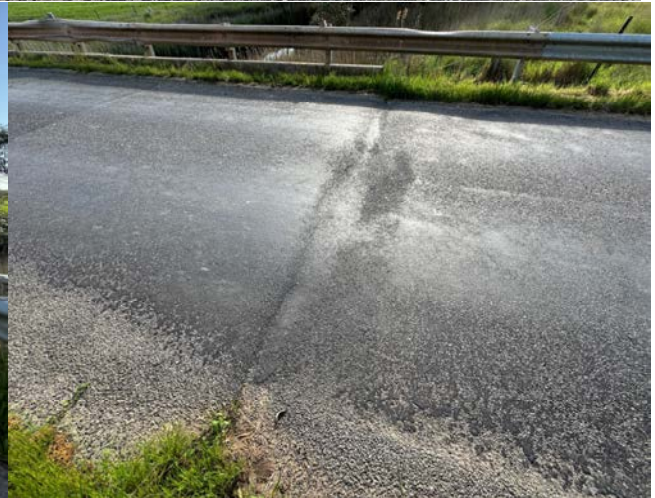
2. The northern approach carriageway has experienced minor settlement, resulting in a rough joint at the north abutment. The expansion joint is entirely obscured by the wearing surface. Additionally, vegetation growth has been observed on the bridge deck. Monitor at Level 1 bridge inspection.

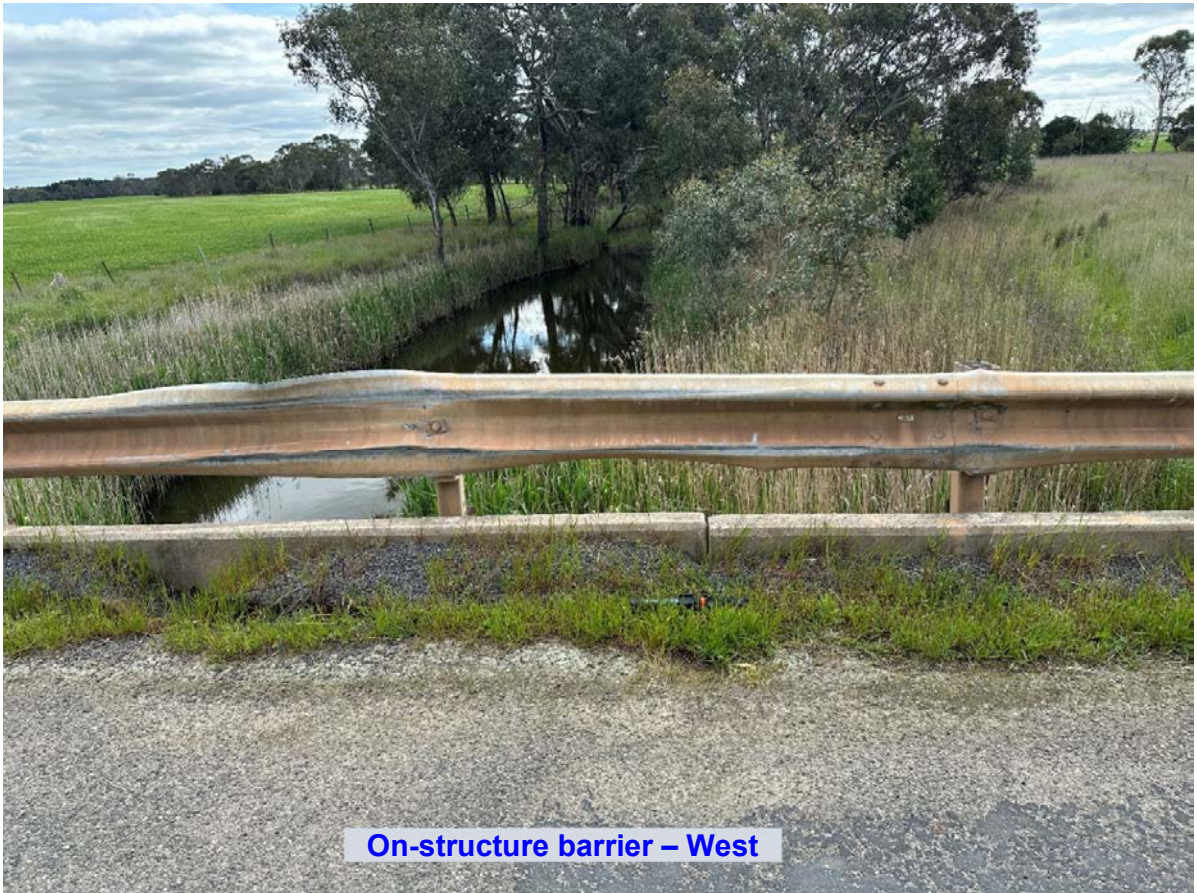
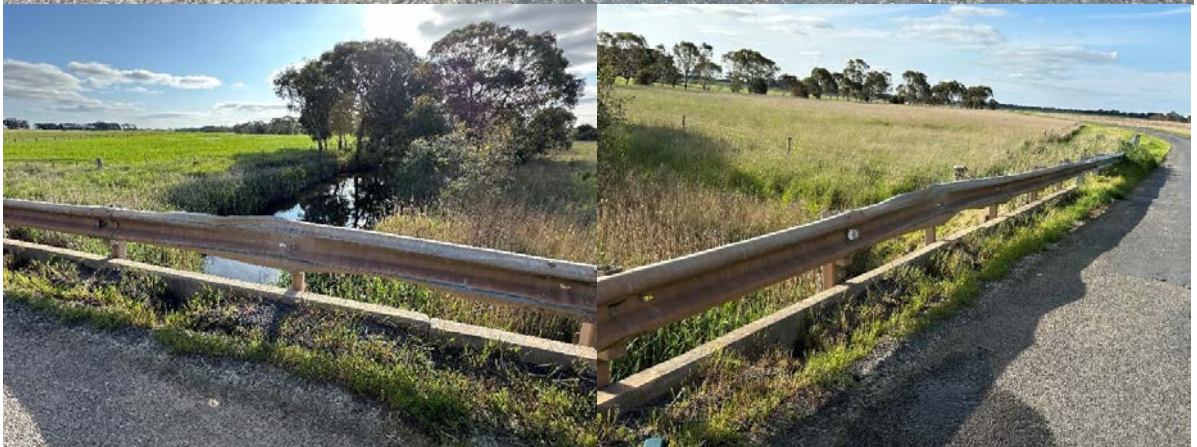
- Impact damage has been observed due to vehicle collision resulting significant damage to the W-beam.

- The bridge on-structure barrier shows multiple impact damages due to vehicle collisions. Damaged W-beams should be replaced, and the barrier reinstated in accordance with VicRoads specifications. (High Priority)

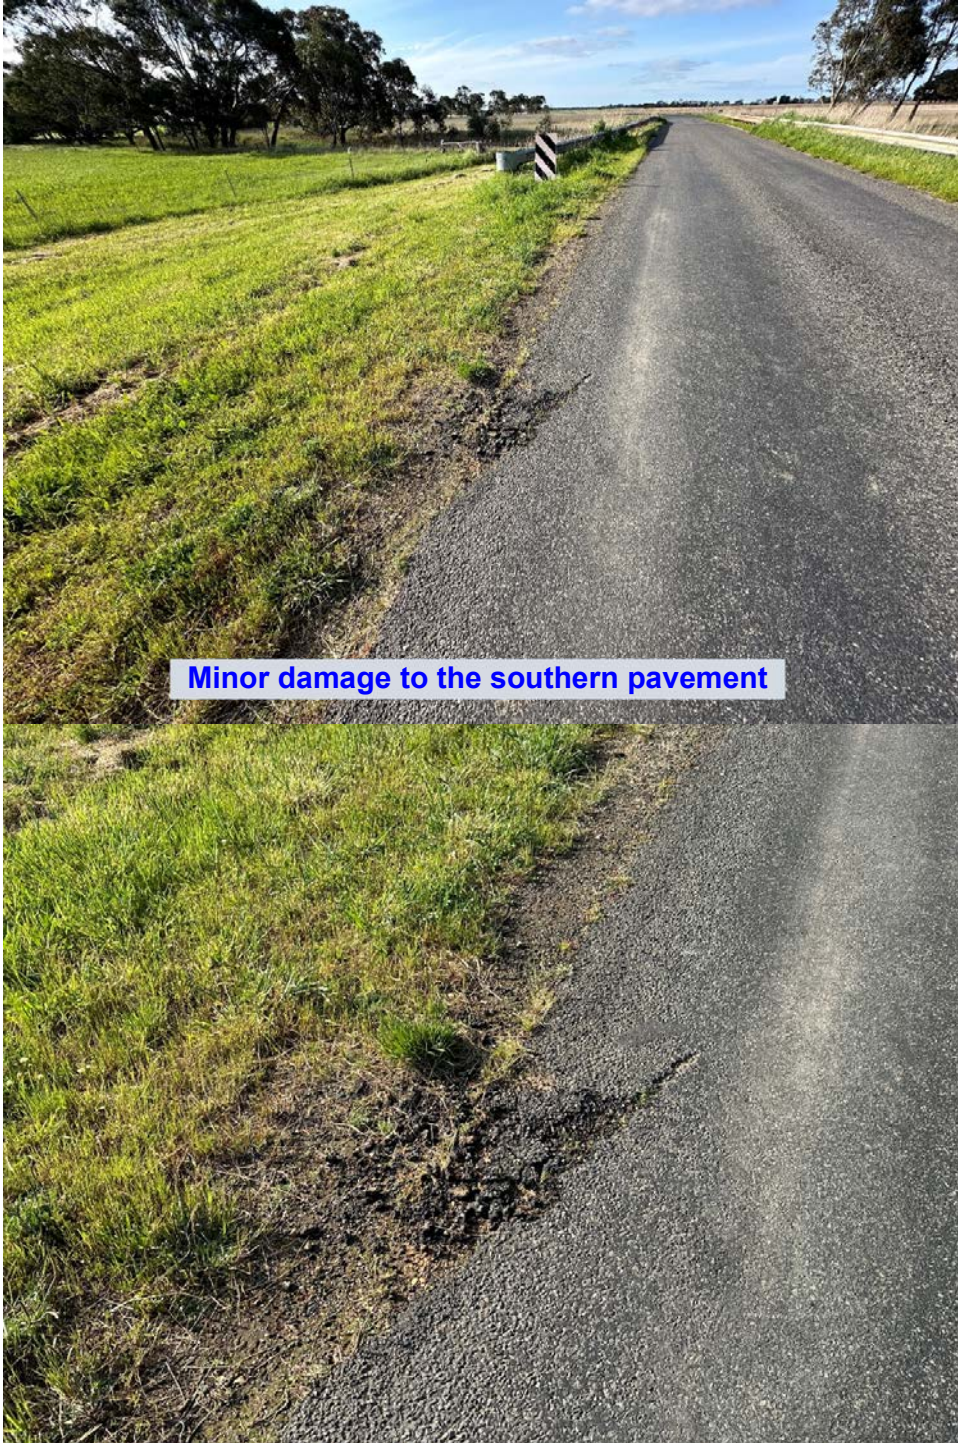
4. Minor damaged has been observed on the southern carriageway.

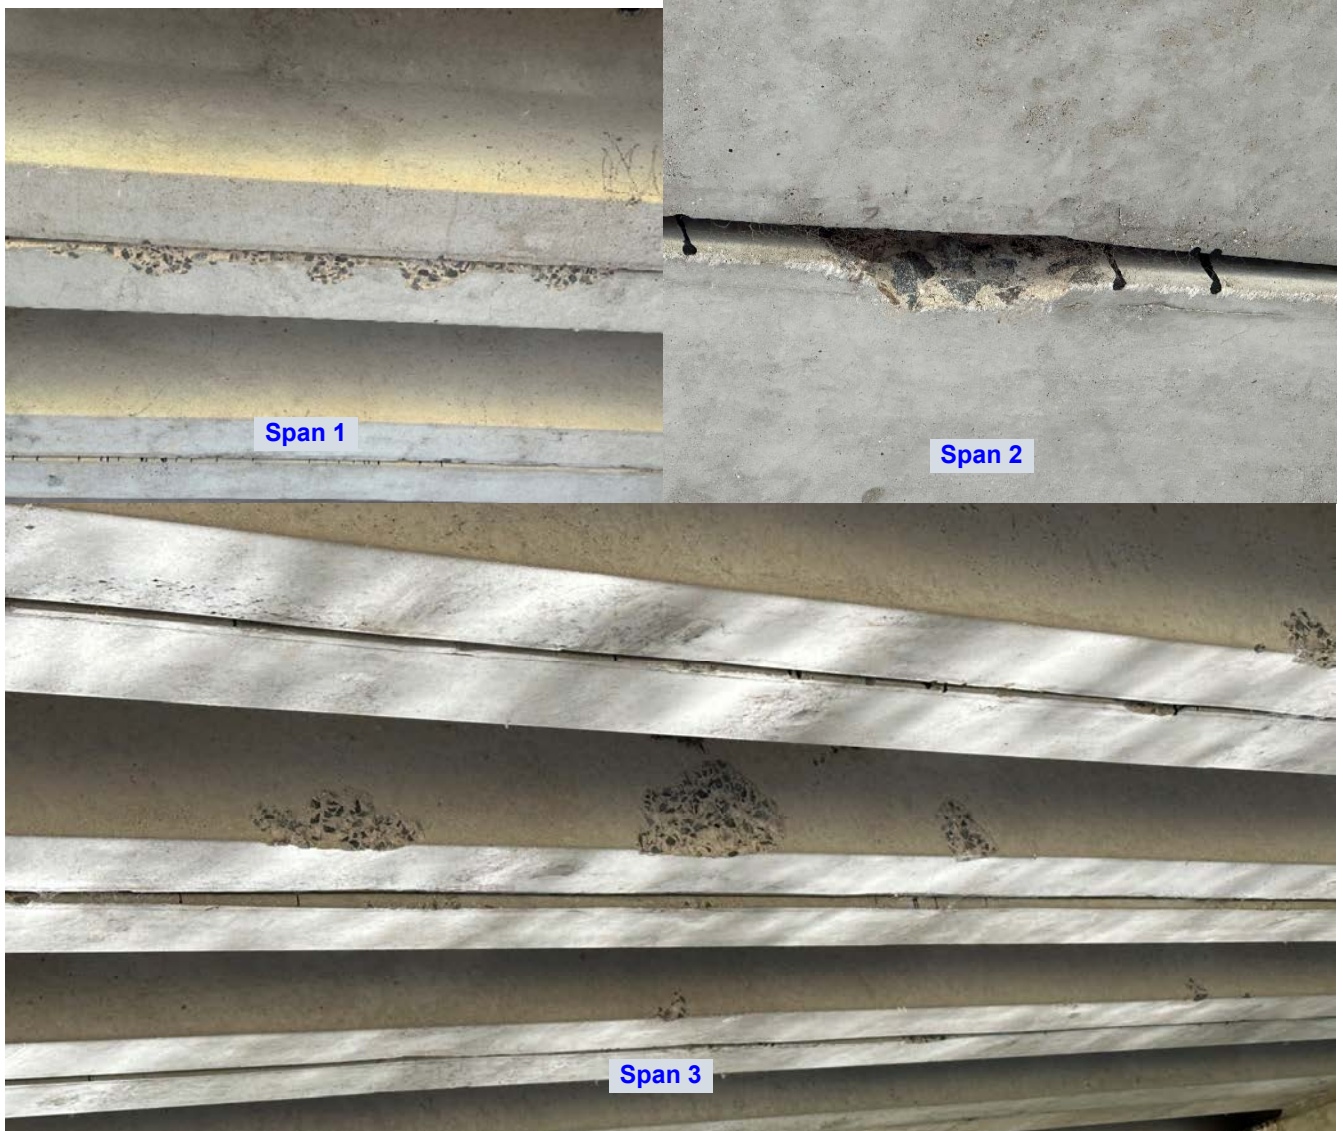
5. Severe to moderate cracking and concrete spalling have been observed in all three spans. Evidence of severe to minor corrosion is present. All cracks appear to be aging cracks, and no flexural or shear cracks have been observed.

- Severe concrete spalling and cracks, in addition to minor spalling, were observed on the U-slab units. All deteriorated concrete and corroded reinforcement should be removed, with standard concrete patch repairs carried out to rectify the U-slab deck. All corroded reinforcement should be replaced by welding N-grade reinforcement to the existing bars. (High Priority).

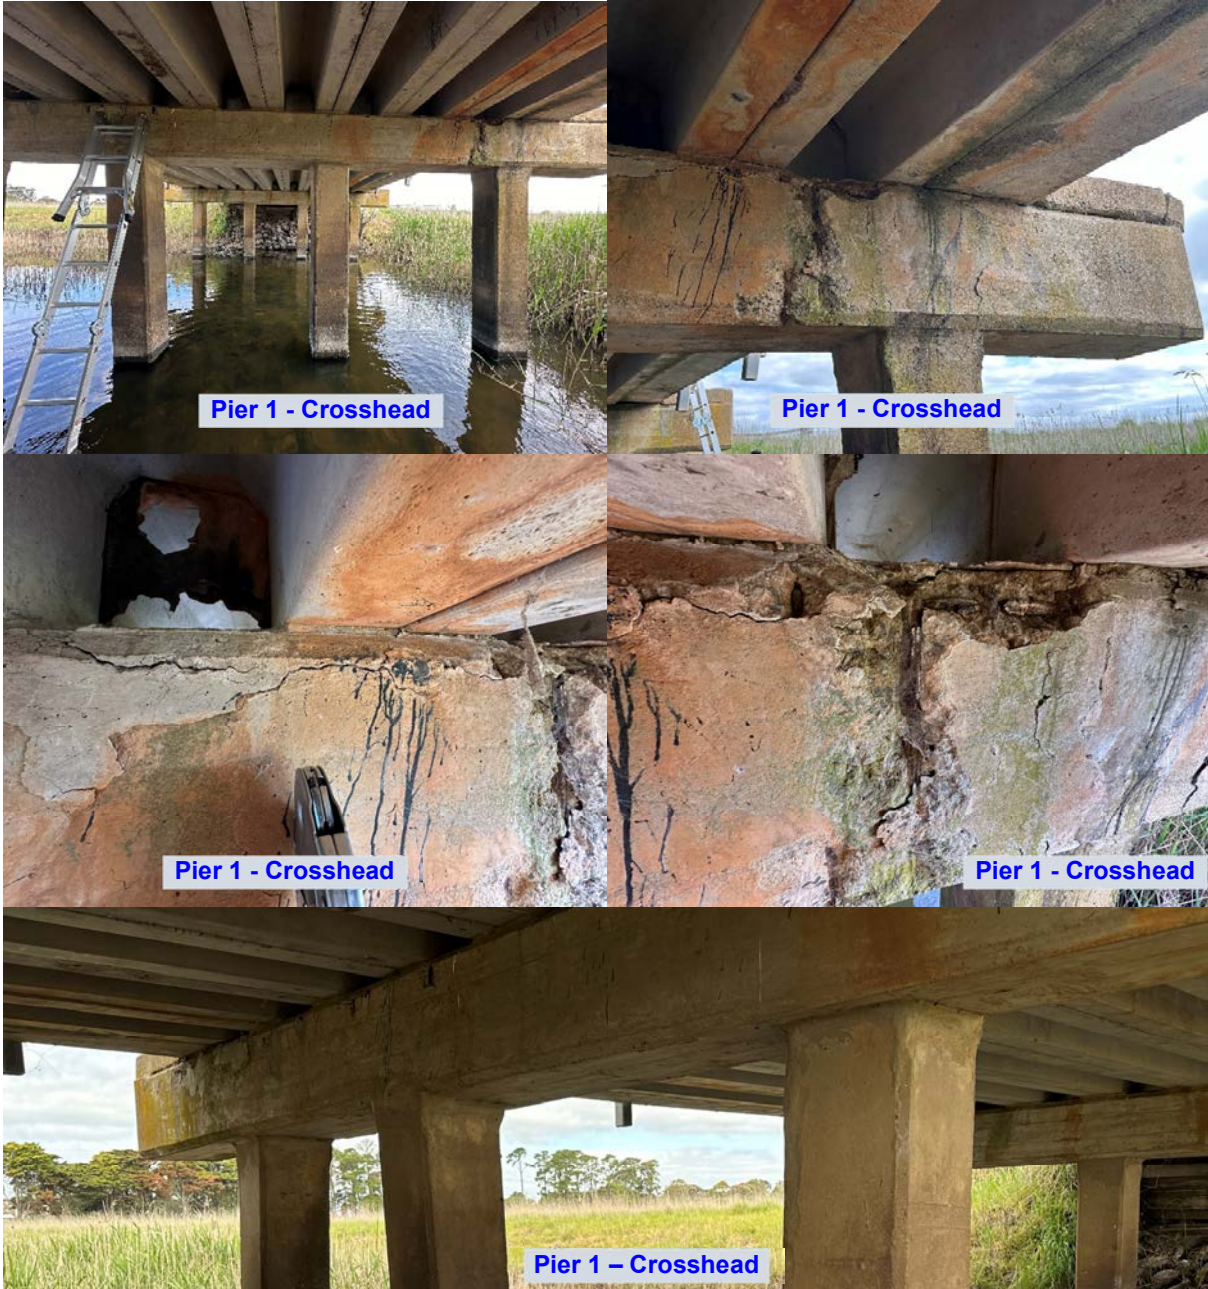
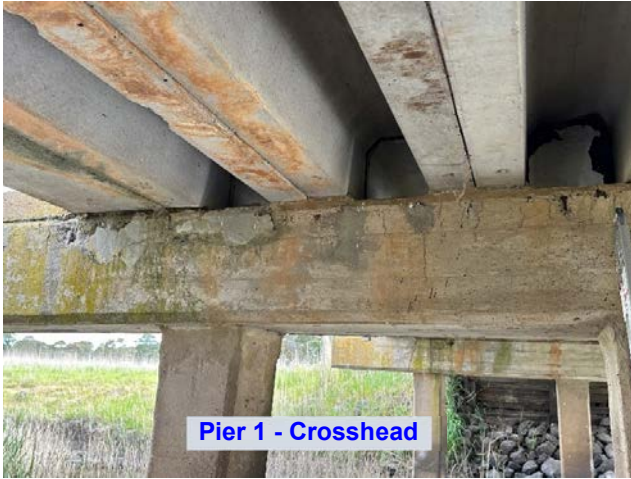
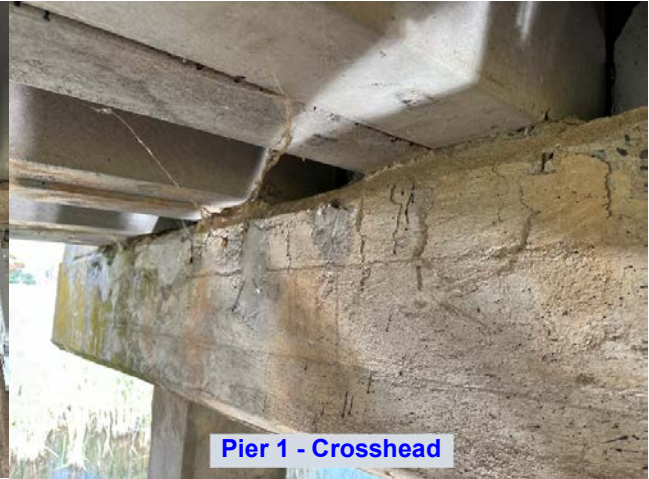
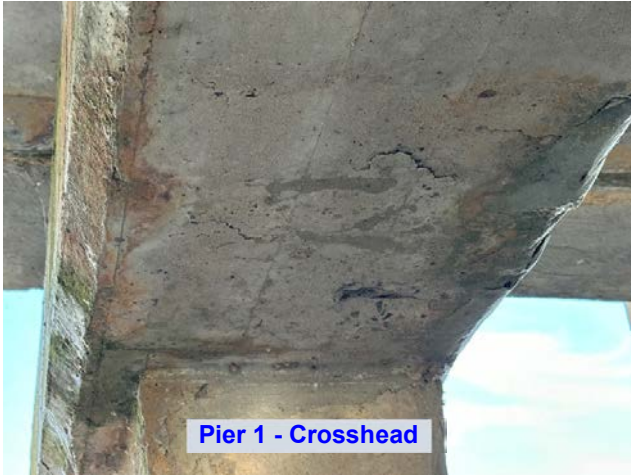
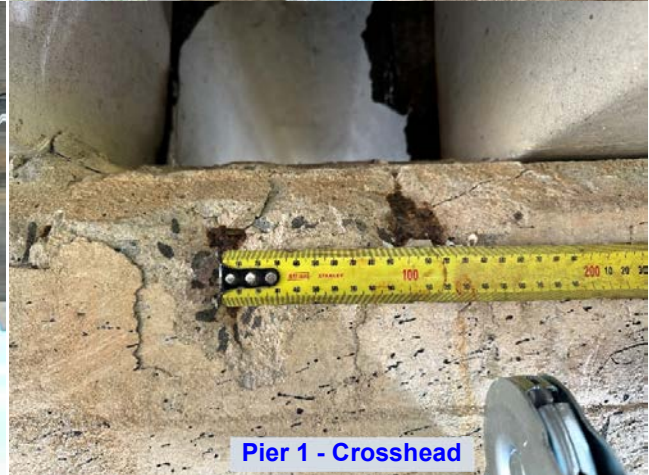
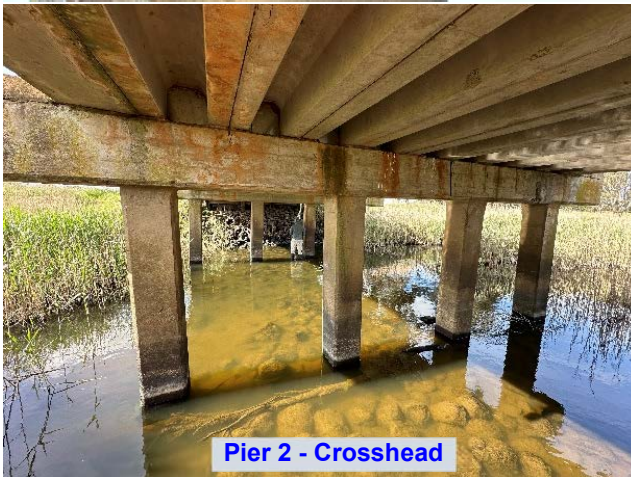
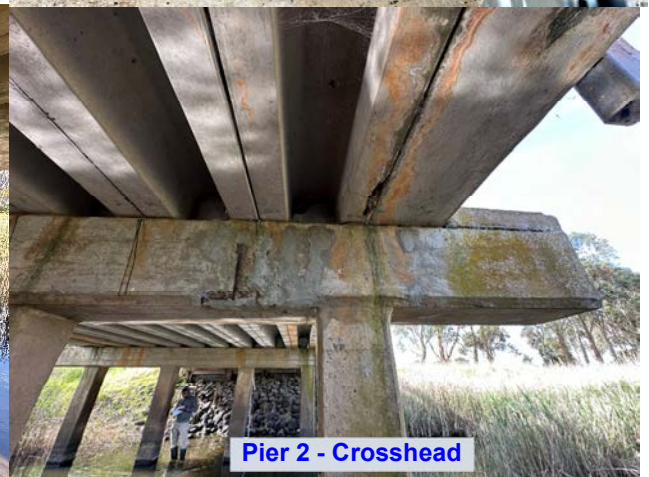
The pier headstocks exhibit significant concrete spalling and corrosion of reinforcing steel, resulting in a substantial reduction in shear load rating capacity. Implementing concrete repairs and reinstating the corroded reinforcement in accordance with AS 5100.8:2017 is expected to enhance the shear load rating, as outlined in Table 4.

6. Severe to moderate cracking and concrete spalling have been observed on the pier crossheads. Evidence of moderate to severe corrosion is present. All cracks appear to be aging cracks, and no flexural or shear cracks have been observed.

- The pier crossheads exhibit moderate to severe aging cracks, attributed to low concrete cover and significant cross-sectional loss of reinforcement. All deteriorated concrete and corroded reinforcement should be removed and replaced with high-ductility N-grade reinforcement. Where lap length is unachievable, the new reinforcement should be welded to the existing bars. Standard concrete patch repairs are to be conducted in accordance with VicRoads specifications. The repaired crossheads should meet or exceed the original design capacity. (High Priority)

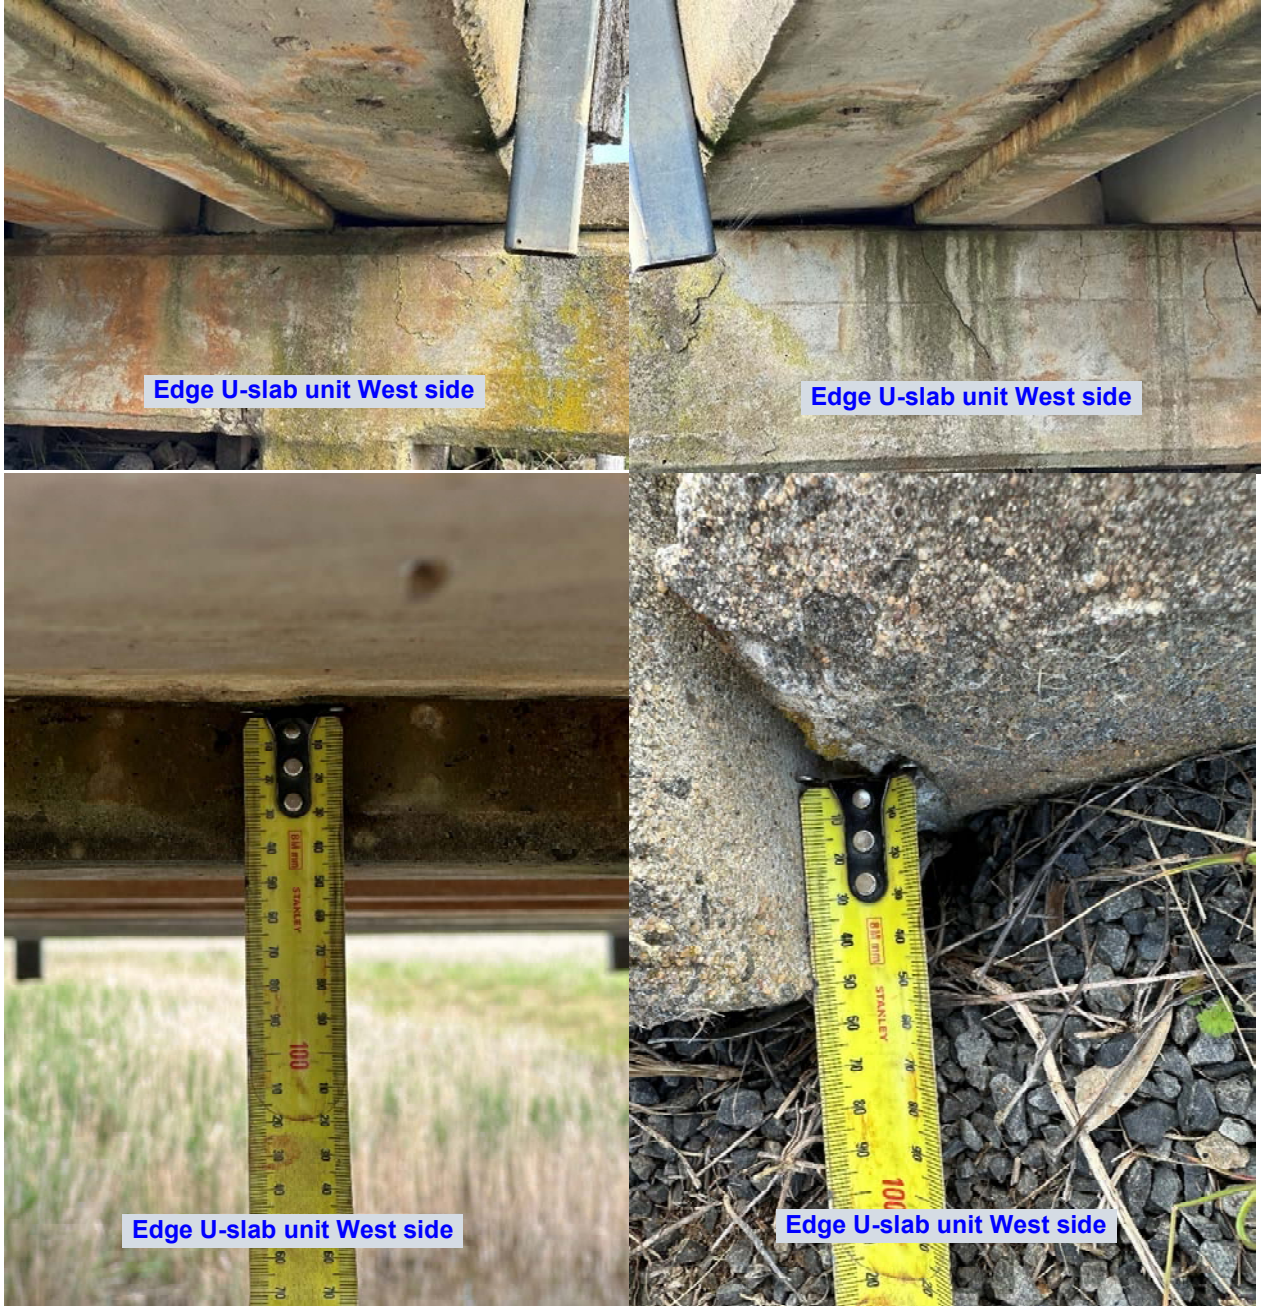
The on-structure barrier (W Beam) has sustained severe impact damage, resulting in the west edge beam of the second span shifting away from the adjacent U-slab segments and tilting slightly. Stoppers have been installed on top of the pier crosshead to provide lateral restraint to the bridge superstructure; however, these stoppers have also been significantly damaged due to the impact.

7. The edge U-slab unit in span 2 is tilted and does not fully seat on the pier crosshead.

- The edge U-slab unit should be repositioned to its original location, ensuring it fully seats on the pier crosshead across the entire width of the edge unit. (High Priority)

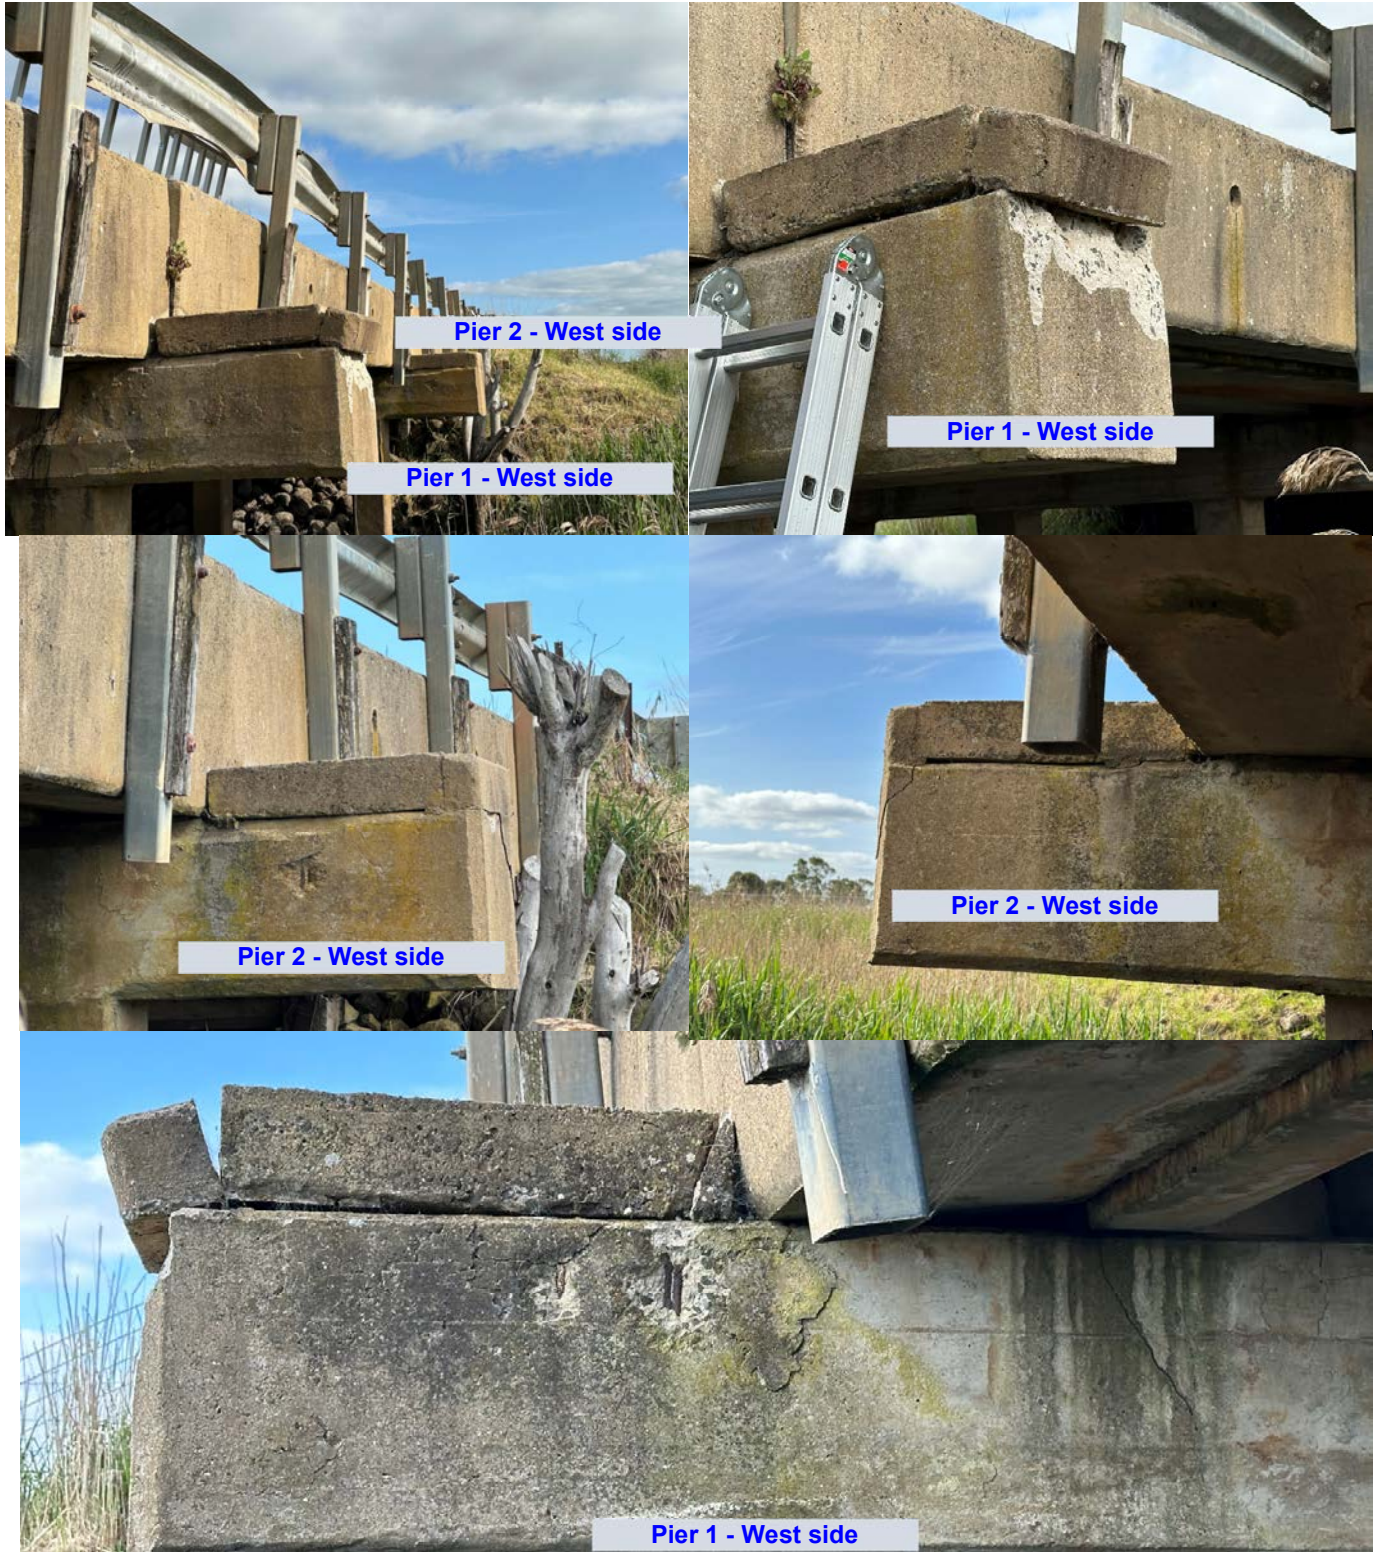
8. The stoppers and pier crosshead are damaged due to the impact from the vehicle collision.

- The pier crosshead and stoppers were damaged due to vehicle impact. All loose concrete to be removed and reinstate stopper by dowelling into the existing crosshead. (High Priority)

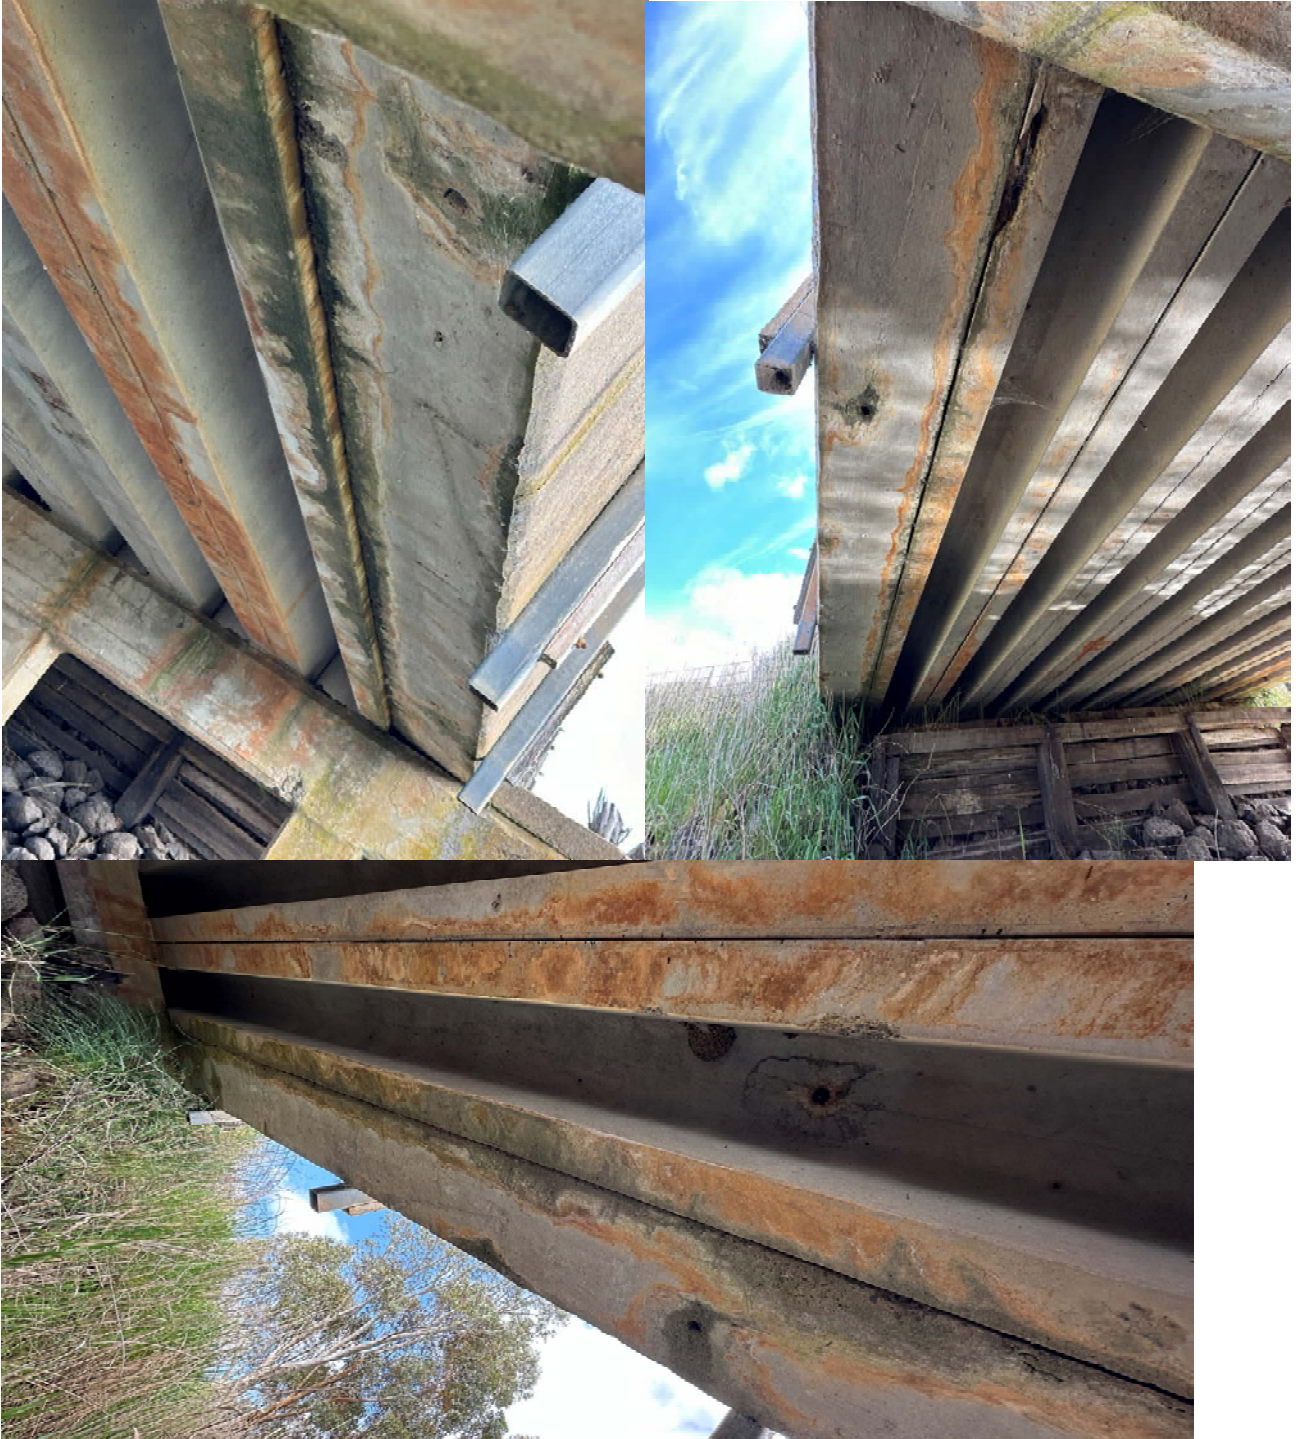
9. Heavy stains have been observed between the edge and first interior U-slab units due to water leaks. This could impact the long-term durability and performance of the U-slab units.

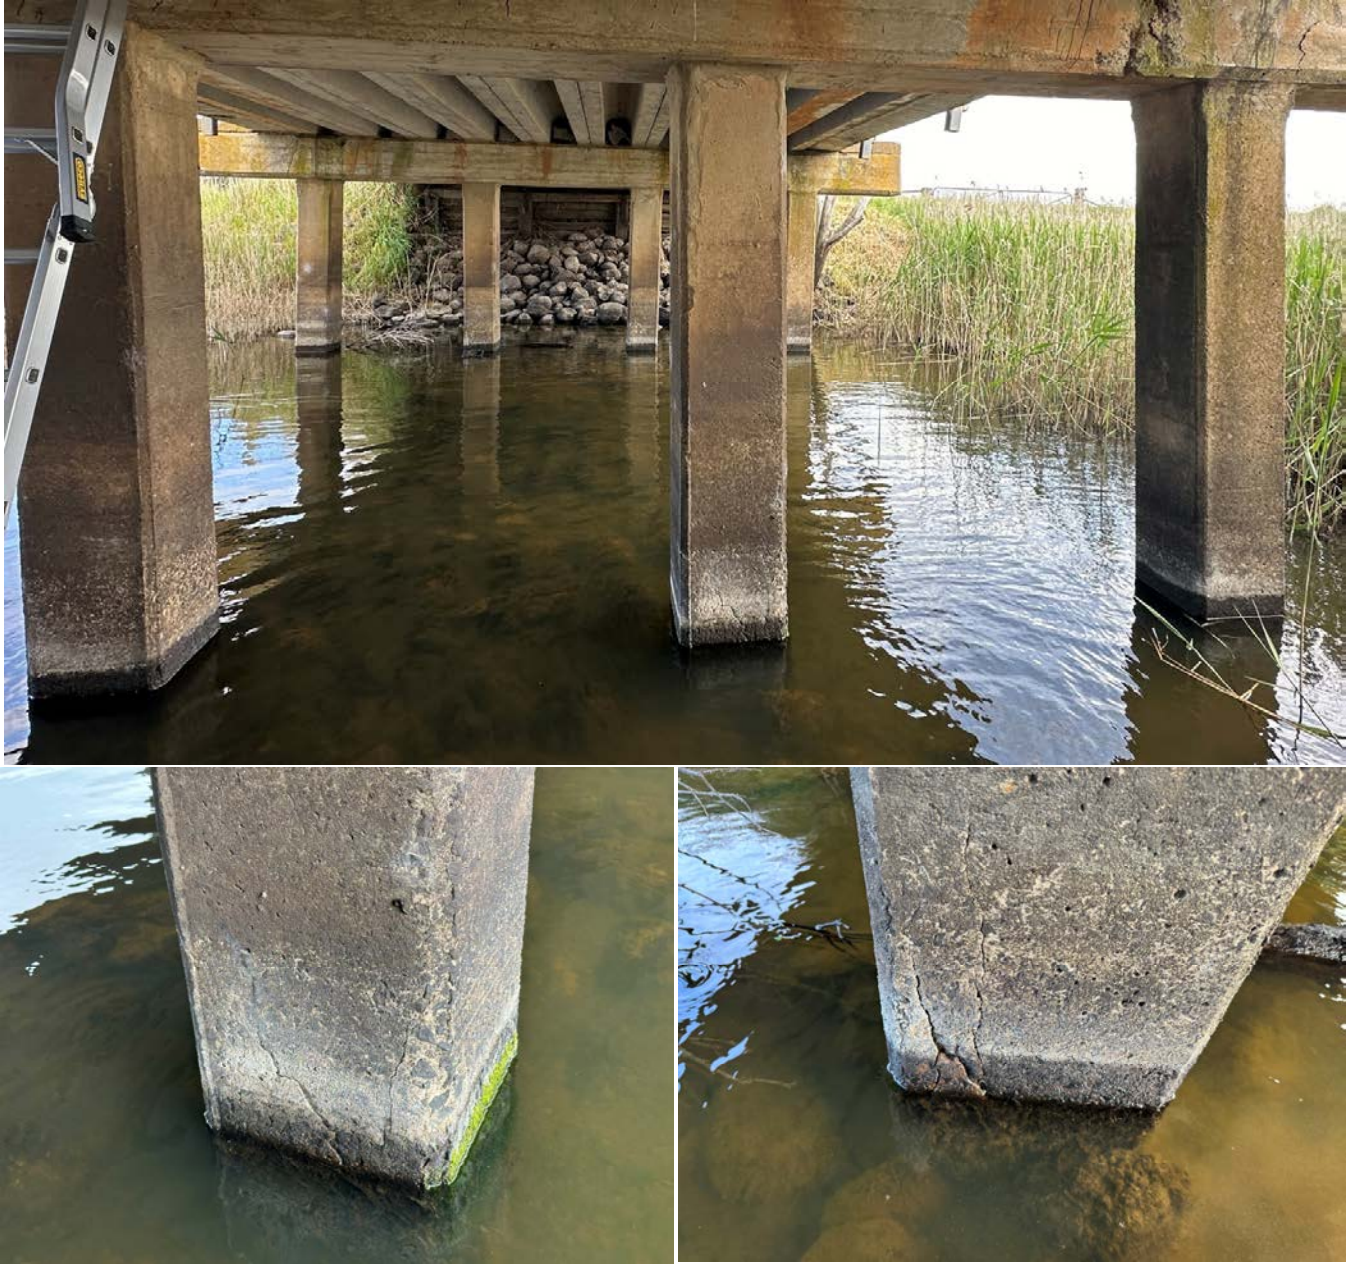
10. Moderate to severe cracks have been observed on forth pile of pier 1.

- Some piles exhibit moderate to severe corner bar splitting, potentially caused by inadequate concrete cover or low cement content in the concrete. As previously mentioned, all deteriorated concrete should be removed, corroded reinforcement replaced with N-grade reinforcement, and the affected areas patched with approved concrete repair material. (Medium Priority)
